Bond Durability of Grit-blast and Silane treated Metallic Adherends Bonded with Room Temperature Curing Adhesives

DSTO-TR-1187

Airframes and Engines Division
Aeronautical and Maritime Research Laboratory

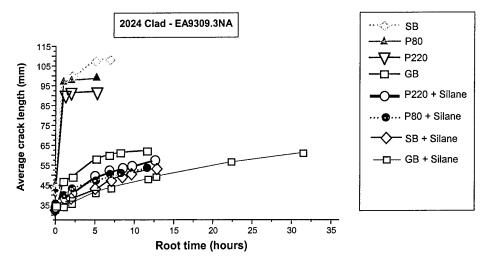
Figure 1 and Figure 2 indicate the crack-growth as a function of exposure time to a humid environment for Al-2024 T3 Clad aluminium alloy adherends bonded with EA9309.3 NA. The surface pre-treatments used are indicated in the graph legend.

Figure 1 Bond durability data for Al-2024 T3 clad aluminium bonded to EA9309.3NA paste adhesive as a function of the surface pre-treatment.

Table 4 indicates the fracture surface compositions from the failed wedge test samples indicated in Figure 1. The data indicates that failure occurs predominantly between the adhesive and aluminium interface for the abraded or grit-blasted surfaces and within the silane layer for the abraded surfaces treated with epoxy-silane. Evidence for this failure is provided by the high carbon concentration present on the adhesive face that is indicative of the epoxy adhesive and the low levels of aluminium. All abraded fracture surfaces indicated silicon that may come from grit embedded in the adhesive present on the abraded aluminium surface and/or from the silica spheres present in the EA9309.3NA adhesive, which are used to control bondline thickness. The epoxy-silane treated samples indicated an increase in the silicon levels on the complementary fracture surfaces, indicating the presence of the coupling agent.

The fracture surfaces from these failed samples are displayed in Appendix 1 in Figure A23. The images indicate that the abrasion procedures lead to large areas of adhesive failure. The addition of the silane to the abraded surfaces reduces the area of adhesion failure, however, the shiny appearance of the metallic adherend is still evident. In contrast, the grit-blast and grit-blast + silane treatments significantly reduce the area of adhesion failure. The failure surface from the grit-blast + silane treatment also shows markedly reduced crack propagation infront of the region of cohesive failure of the EA9309 adhesive, caused by the wedge insertion in the dry environment.

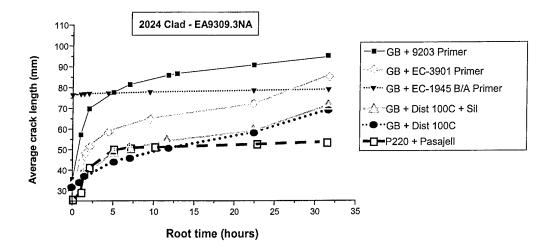
Figure 2 Bond durability data for Al-2024 T3 clad aluminium bonded to EA9309.3NA paste adhesive as a function of the surface pre-treatment.

Table 5 indicates the fracture surface compositions for the failed wedge samples indicated in Figure 2. The abraded surfaces that have been treated with commercially available primers, and that are recommended by the adhesive manufacturer (9203 primer), all indicated failure occurred within the primer layer, suggesting the primer is not hydrolytically stable in the humid environment used to conduct the wedge test. Evidence for this failure is provided by the high carbon and silicon levels on the metal and adhesive surfaces and the low aluminium signal on the metal failure surface.

Figure A24 in Appendix 1 displays the fracture surfaces from the wedge test samples shown in Figure 2. The sample treated with EC1945B primer indicates a green tinge on the surface that has a metallic appearance, confirming the XPS analysis that indicated cohesive failure of the primer layer resulted in crack propagation. Another feature of Figure A24 is the adhesive failure surface of the Pasajell treatment. The metallic appearance, consistent with adhesion failure identified with XPS analysis, indicates an area larger than the adhesion failure area observed for the grit-blast and silane treatment, refer Figure A23. This suggests that the silane treatment provides a more durable surface treatment than the Pasajell, despite the similar final crack-length values measured for the respective treatments, Figures 1 and 2.

The addition of a range of commercially available primers in place of the silane treatment, refer Figure 2, to the grit-blasted surface suggests that they are all inferior to the silane treatment. Fracture analysis of these primed surfaces, refer Table 5, indicates

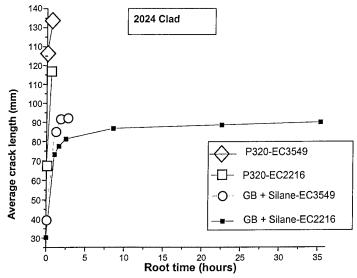
Figure 6 indicates the crack-growth as a function of exposure time to a humid environment for Al-2024 T3 Clad aluminium alloy adherends bonded with EC2216. The surface pre-treatments used are indicated in the graph legend.

Figure 6 Bond durability data for Al-2024 T3 clad aluminium bonded to EC2216 and EC3549 paste adhesive as a function of the surface pre-treatment.

Figure 3 to Figure 6 indicate similar general trends in durability as a function of surface treatment. Grit-blast abrasion followed by silane treatment provides a marked improvement in durability of bonds formed between the paste adhesive and the clad Al-2024T3 surface. In all cases the grit-blast and silane treatment prevents significant crack-growth once the wedge is exposed to a high humidity environment. In contrast the abrasion procedures exhibit very high crack-growth rates and often fail within the first few hours of testing. Images of the failure surfaces in Appendix 1 suggest that the failure modes are similar to those observed for the EA9309.3NA adhesive, with the silane improving the hydrolytic stability of the interfacial region. The performance of the EC2216 and EC3549 adhesives is obviously inferior to the other paste adhesives despite their satisfactory initial crack-length values and the reported high peel strength values of 25piw. The reason for the poor performance of the EC2216 and EC3549 adhesives is presumably due to the degradation in mechanical properties which occurs at 50°C, refer Table 3. It should be noted, however, that the silane in both cases

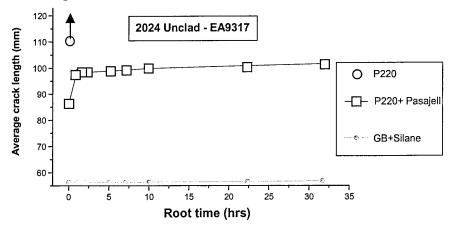
Figure 9 indicates the crack-growth as a function of exposure time to a humid environment for Al-2024 T3 Unclad aluminium alloy adherends bonded with EA9317. The surface pre-treatments used are indicated in the graph legend.

Figure 9 Bond durability data for Al-2024 T3 unclad aluminium bonded to EA9317 paste adhesive as a function of the surface pre-treatment

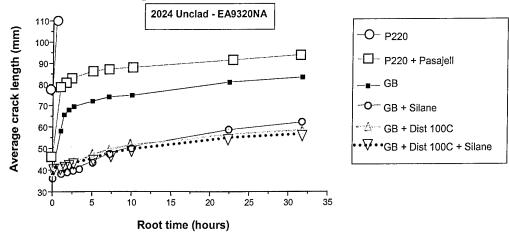
Figure 10 indicates the crack-growth as a function of exposure time to a humid environment for Al-2024 T3 Unclad aluminium alloy adherends bonded with EA9320.NA. The surface pre-treatments used are indicated in the graph legend.

Figure 10 Bond durability data for Al-2024 T3 unclad aluminium bonded to EA9320.NA paste adhesive as a function of the surface pre-treatment.

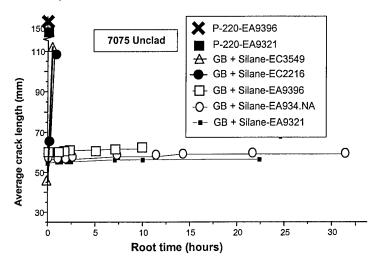
Figure 17 indicates the crack-growth as a function of exposure time to a humid environment for Al-7075 T6 Unclad aluminium alloy adherends pre-treated with gritblast and silane prior to bonding with EC3549 B/A, EC2216, EA9396, EA9321, EA934.NA, .

Figure 17 Bond durability data for Al-7075 T6 unclad aluminium pre-treated with gritblast and silane prior to bonding with EC3549, EC2216, EA9396, EA9321, EA934.NA paste adhesive

Figure 17 indicates that the bond durability for the EA9321 and EA9396 adhesives bonded to Al-7075T6 alloy treated with the grit-blast and silane method are significantly improved relative to the abrasion treatment. The relative durability of the grit-blast and silane treated samples are slightly poorer than those observed for the clad Al-2024 alloy, but similar to the unclad Al-2024 alloy. The EA934 adhesive bonded to the grit-blast and silane treated Al-7075 alloy shows similar durability to that

observed for the Al-2024 unclad alloy. Both the EC3549 and EC2216 adhesives show poor durability for the grit-blast and silane treatment, although this is still a significant improvement on the P-220 abraded samples, which failed almost immediately in the dry environment after wedge insertion. The poor performance of the EC3549 and EC2216 adhesives was also observed for the Al-2024T3 alloys, refer Figure 6 and Figure 13.

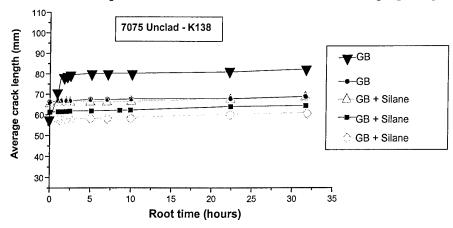
Figure 18 indicates the crack-growth as a function of exposure time to a humid environment for Al-7075 T6 Unclad aluminium alloy adherends bonded with K138. The surface pre-treatments used are indicated in the graph legend.

Figure 18 Bond durability data for Al-7075 T6 unclad aluminium bonded to K138 paste adhesive as a function of the surface pre-treatment.

Figure 18 indicates the relative durability performance for the grit blasted and grit-blast followed by silane treated Al-7075T6 alloy bonded to K138 adhesive. Some inconsistent results were observed for the grit-blasted treatment as shown in Figure 18. Observation of the fracture surfaces for the poor grit-blast samples and the grit-blast and silane samples, refer Figure A36 in Appendix 1, revealed that the grit-blast sample had failed at the adhesive-aluminium interface, whereas the grit-blast and silane treated surface had failed cohesively, as was observed for the Al-2024T3 alloy samples. This result provides evidence that the silane treatment improves the hydrolytic stability of the interfacial region for aluminium to K138 adhesive bonds, and suggests that the excellent durability observed for the infield repair, refer 4.1.3, would be further enhanced by the addition of silane to the grit-blasted surface. The result also provides further indication that the adhesive bonds formed with Al-7075T6 unclad aluminium alloy are more sensitive to environmental exposure than the Al-2024T3 alloy.

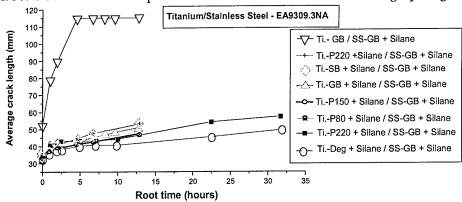
Figure 20 indicates the crack-growth as a function of exposure time to a humid environment for Titanium 6A1-4V/ 304 Stainless Steel adherends bonded with EA9309.3 NA. The surface pre-treatments used are indicated in the graph legend.

Figure 20 Bond durability data for Titanium 6A1-4V/Stainless Steel adherends bonded to EA9309.3NA paste adhesive as a function of the surface pre-treatment.

Table 6 indicates the fracture surface compositions from the failed titanium wedge samples indicated in Figure 20.The fracture surfaces show similar results to the aluminium wedge samples in Table 4. The fracture appears to propagate at the titanium-adhesive interface and particularly within the silane layer. Evidence for this mode of fracture is provided by the high carbon and low titanium levels on the metal surface and the presence of silicon on both the metal and adhesive surfaces.

Figure 20 indicates the bond durability performance for titanium and stainless steel adherends bonded with EA9309.3NA. These specimens were manufactured in response to a request from HS816 SQN concerning poor performance of adhesively bonded Seahawk Centering Socket Liners on the Main Rotor Hub[10]. The results indicate that addition of silane to an abraded or grit-blasted surface significantly improves bond durability. The results are also consistent with those for the titanium samples shown in Figure 19 and indicate that there is little difference in bond durability for the titanium adherends that are simply degreased or degreased and abraded or grit-blasted prior to silane application. The data in Table 8 indicates that the P-80 abrasion and grit-blasting increased the surface roughness of the titanium surface to the greatest extent. However, the minimal effect of abrasion or grit-blasting on the silane performance may suggest that due to the titanium surface hardness, these procedures do not increase surface roughness to a level that affects bond durability. The comparison of the data in Table 7 and Table 8 for the aluminium and titanium alloys, shows that the aluminium surface roughness is significantly greater than the titanium surface roughness. An improved surface pre-treatment method for bonded repairs of the Main Rotor Hub Socket Liners may simply require degreasing and water wiping the titanium surface to insure a water-break free surface prior to silane application. The current procedure involves an abrade and solvent method followed by application of EA9203 primer. This procedure has been tested at AMRL and shown to be particularly ineffective. The results in Table 5 and Figure 2 indicate that this primer produces a hydrolytically unstable and mechanically weak interfacial region.

Failure surface analysis of the titanium/stainless steel wedge samples, refer Table 6, indicates that all fractures occur near the titanium-adhesive interface, within the silane layer. The improvement in durability, relative to the grit-blast only surface, presumably indicates the increase in the hydrolytic stability of the adhesive bonds resulting from the silane treatment. Figure A38 in Appendix 1 also shows the failure surfaces of the titanium/stainless steel wedge specimens. In all cases failure propagated at the interface between the adhesive and the titanium adherend. The stainless steel surfaces were all treated with the grit-blast and silane method and clearly exhibited greater durability than the titanium surfaces treated with the same procedure.

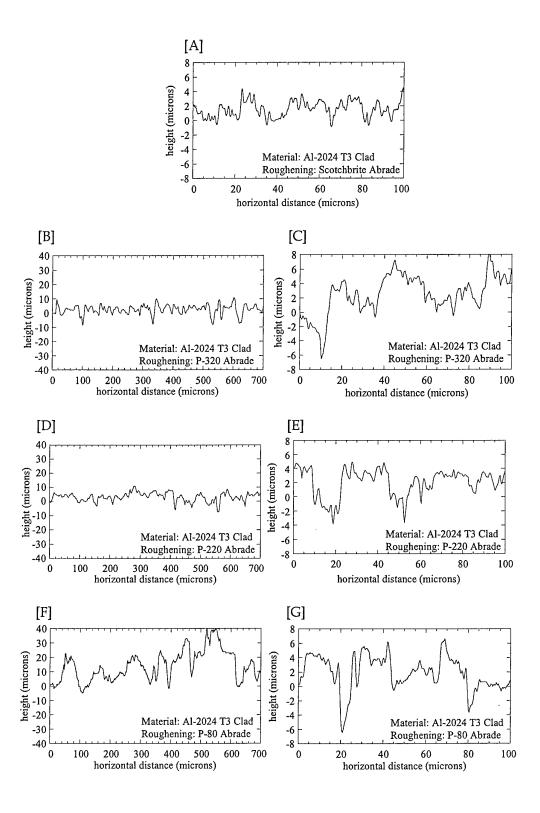
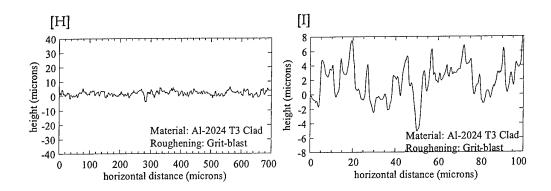
Figure 21 [A] to [I] indicate line profiles of Al-2024T3 clad aluminium abraded and gritblasted, measured using the Perthometer.

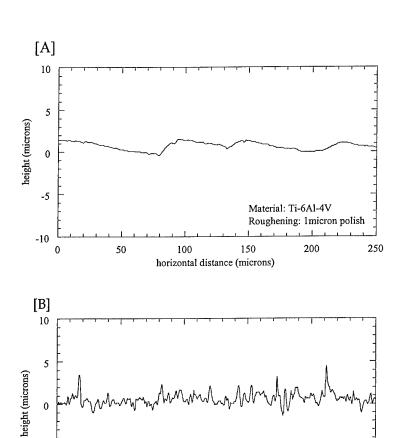
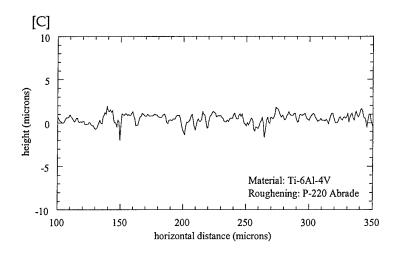
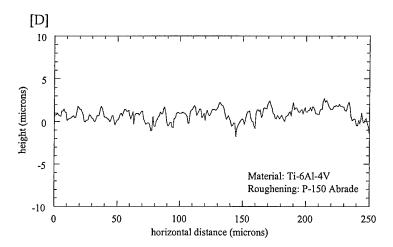
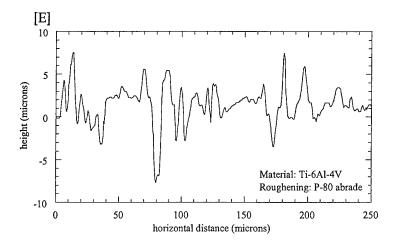
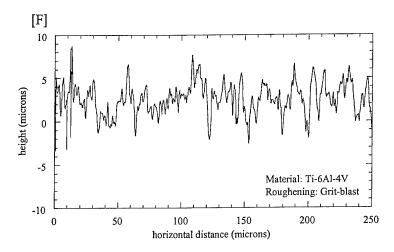
Figure 22 Figures [A] to [F] indicate line profiles of Titanium 6Al-4V abraded and gritblasted, measured using the Perthometer.

scratches introduced by the abrasion. The grit-blasted titanium surface actually produces similar surface roughness to that observed for the aluminium surface and is similar to the P-80 abraded titanium surface. However, the grit-blasted titanium surface indicates that the angle of the surface features are notably greater than those observed for the abraded surfaces.
